# Lighting Recommendations for the Social Security Administration Frank Hagel Federal Building in Richmond CA

# Final Report

## Lighting Recommendations for the Social Security Administration Frank Hagel Federal Building

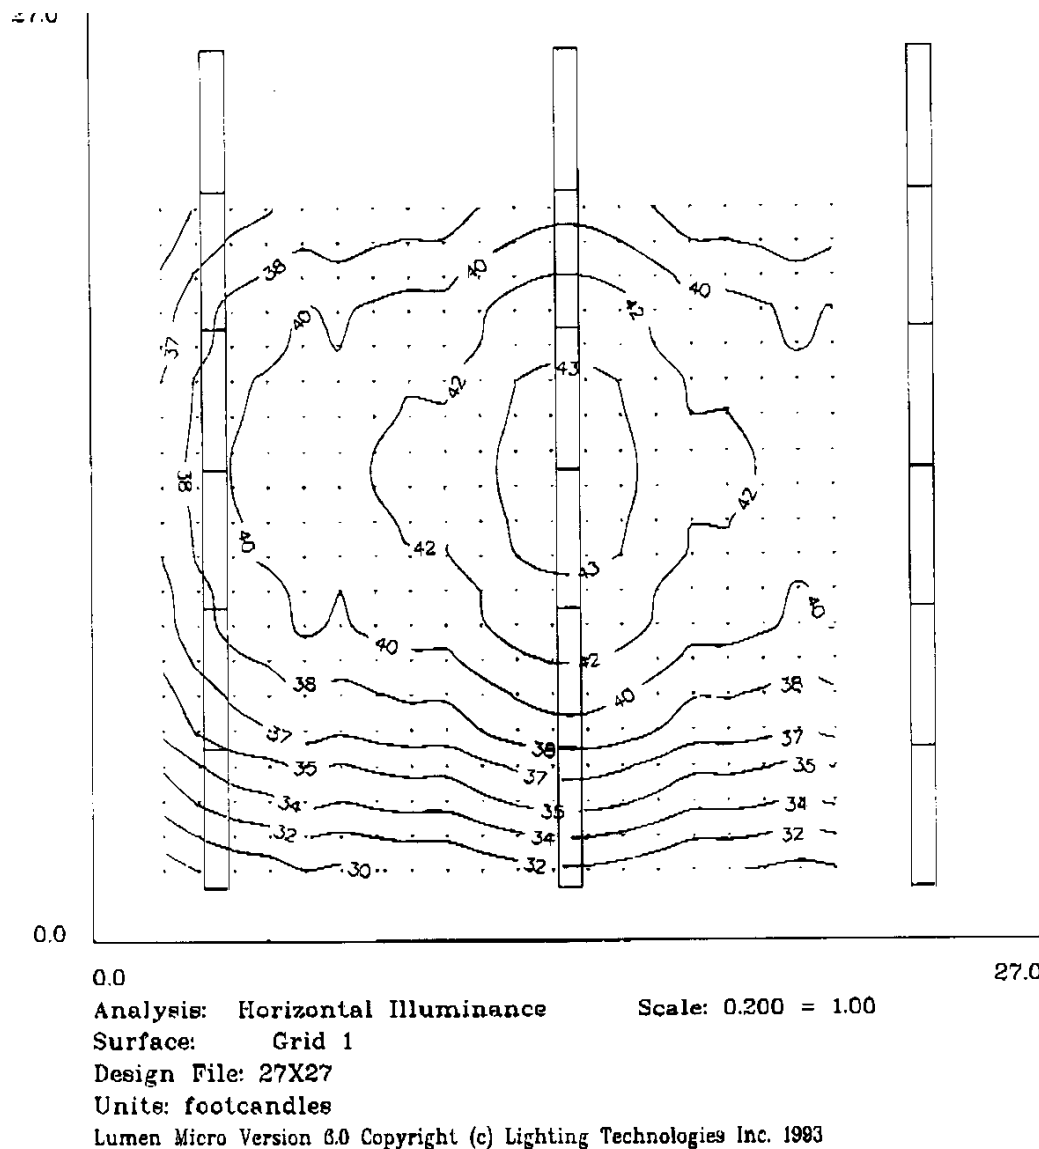
Figure 3.    Illuminance distribution from indirect lighting system. Values calculated using Lumem Micro Version 6.0.

Average illuminance: 38.7 footcandles
Minimum: 28 footcandles
Maximum: 44.1 footcandles

It should be noted that this solution requires a ballast with a high ballast factor (1.25) to obtain satisfactory light levels. Use of normal ballast factor will result in lower illumination levels. It should be noted that the above analysis does not include the effects of the partitions which will reduce the delivered light levels by about 20%.

To provide higher light levels than the 38 footcandle average will require supplemental task lights which could either be located under the storage cabinets or as articulated arm task lights that are mechanically connected to the desks. Because of variability and user preference, this report does not make specific recommendations for type of task light. The articulated arm task lights used in other portions of the building would serve this purpose well.
